Yield Enhancement in Production of CMOS Image Sensors: Defect Analysis and Solutions

Liviu Oniciuc, Abhinav Agarwal, Joseph Valenzuela, Daniel Chica, Loc Truong;
Forza Silicon (AMETEK Inc.); 2947 Bradley Street Suite 130, Pasadena, California, 91107, USA

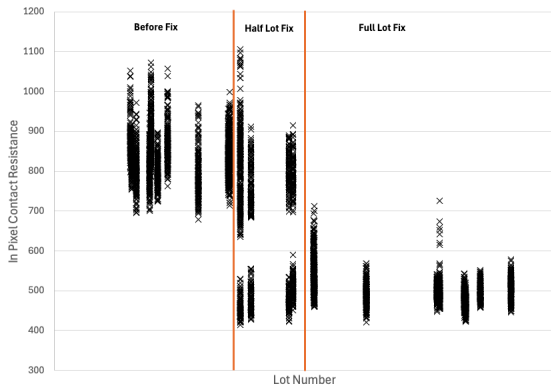
Figure 6. In pixel contact resistance: [Lots] vs Resistance [Ω/ct]

A new cleaning step was added to the wafer manufacturing process to improve the in-pixel contact resistance with results shown in Figure 6.

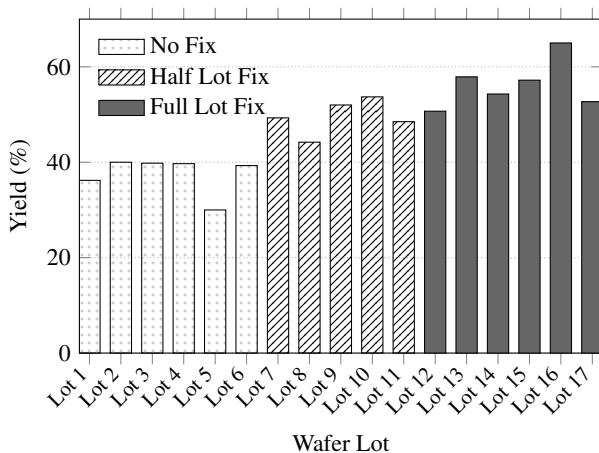
Figure 7. Wafer lot yield comparing the in-pixel contact resistance fix

The new process recipe was applied to half of the wafers in limited pre-production lots. The results demonstrated a clear correlation between the revised process and a reduction in wafer-border defects. Tracking the new process recipe within a lot, a clear yield improvement is observed in Figure 7. Additionally, mosaics of the reassembled wafer-defect maps for all wafers in the lot are provided, illustrating the direct correlation between the new recipe and the observed defect reduction (Figure 13).

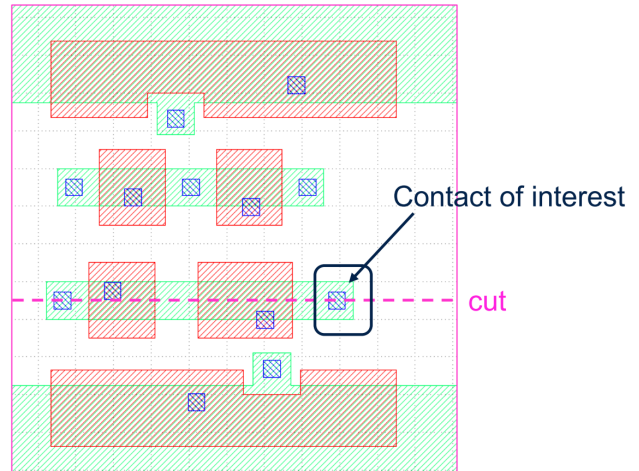
In collaboration with our foundry partners at STMicroelectronics (Crolles, France), a comprehensive microscopy-based analysis was conducted on the identified via (Figure 11) which

Figure 11. Shared via localization
