Surface Modification of an Organic Photoconductor in an Electrophotographic Charging Environment

K. Nauka, Seongsik Chang[^] and Hou T. Ng[^]

Hewlett-Packard Laboratories, Hewlett Packard Company, 1501 Page Mill Road, Palo Alto, California 94304

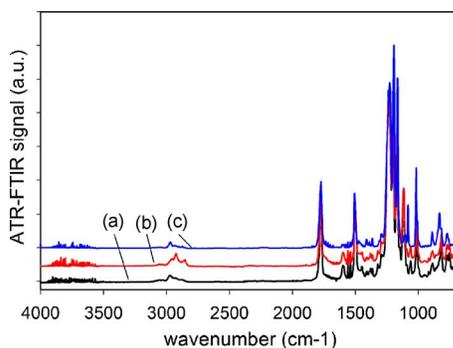
Figure 1. ATR-FTIR spectra of: (a) new photoconductor, (b) photoconductor after an extensive use (approximately 100 K equivalent printed pages), (c) reference commercial polycarbonate. Spectra have been staggered for clarity.

Figure 1 compares the ATR-FTIR absorption spectra of (a) an unused photoconductor, (b) extensively used photoconductor, and (c) a reference undoped polycarbonate. Absorption spectrum of an unused photoconductor is virtu-

ally identical to that of a reference polycarbonate. Most of the features found in the spectrum of a photoconductor can be associated with the corresponding components of a monomer (Bisphenol A) used to synthesize the polycarbonate.⁸ IR spectra of unused and extensively used photoconductors are very similar except for changes in the wave-number region of 2800–3100 cm^{-1} . Figure 2 illustrates details of these changes, namely, the increase of aliphatic methylene (CH_2) stretching vibrations, decrease of aliphatic methyl (CH_3) stretching vibrations, and decrease of the aromatic C-H stretching.⁹ These changes have been found so reproducible that the aliphatic CH_3/CH_2 absorption peak height ratio (parameter Ψ , Figure 3) has been proposed as a parameter used for a routine evaluation of the photoconductor's wear-out.⁵

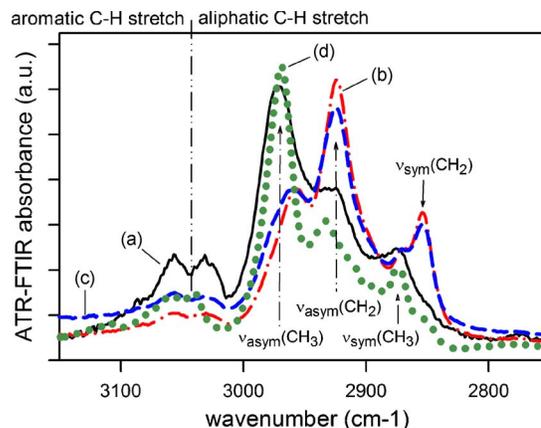
Figure 2. C-H stretching IR absorption region (ATR-FTIR). (a) new photoconductor, (b) used photoconductor (charge roller—after approximately 6 h of continuous use), (c) used photoconductor (scorotron—after approximately 10 h of continuous use), (d) reference polycarbonate. Individual aliphatic stretching vibrations have been identified.

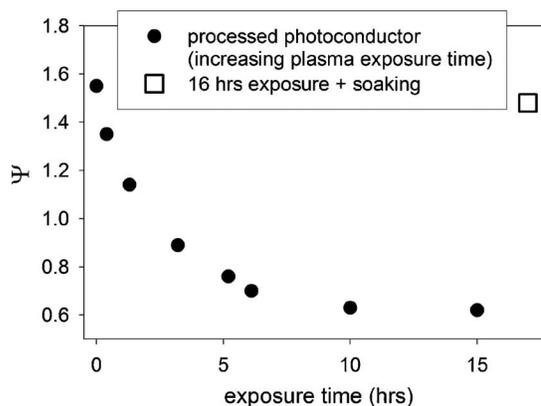
Figure 3. Parameter Ψ (symmetric vibrations CH_3/CH_2 peak height ratio) as a function of processing time (charge roller has been used). Soaking in isopropyl alcohol returns Ψ largely to its original value.

It has been shown⁵ that wiping the processed photoconductor with a solvent-wet cloth or short time soaking in selected solvents can return the Ψ close to its original value (Fig. 3). The soaking method is preferred to wiping because of the possibility of accidentally scratching the

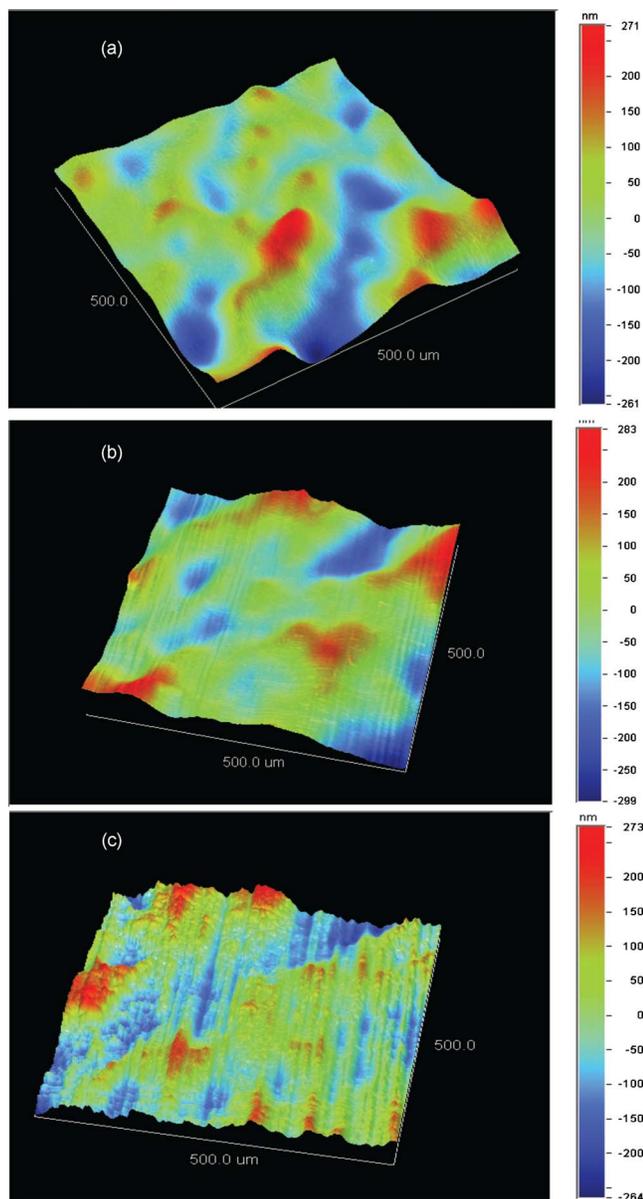
Figure 4. Photoconductor surface topography: (a) new photoconductor, (b) used photoconductor (100 K equivalent printed pages), (c) photoconductor used (as in B) and then soaked in an isopropyl alcohol.

Figure 4 shows surface topography maps (Dektak 150). A new, unused photoconductor shows gentle surface undulation with period of several hundred microns representing typical surface roughness observed for all the investigated organic photoconductors [Fig. 4(a)]. Similar topography was

found after a prolonged processing, as shown in Fig. 4(b). However, a completely different surface topography was observed when the plasma exposed photoconductor was soaked in the aforementioned solvent [Fig. 4(c)]. This surface exhibited linear and sharply defined topographic features superimposed on the top of the original surface undulations. The period of linear roughness is on the order of tens of microns with its depth in the several hundred nanometer range. This pattern was probably created by filamentary discharges from the charge roller following the photoconductor's movement direction.¹⁰ Fig. 4 suggests that extended exposure to electrophotographic plasma damages the photoconductor surface. However, the resulting thin parasitic film covering the surface follows the contour of an original photoconductor and hides the newly created surface damage.

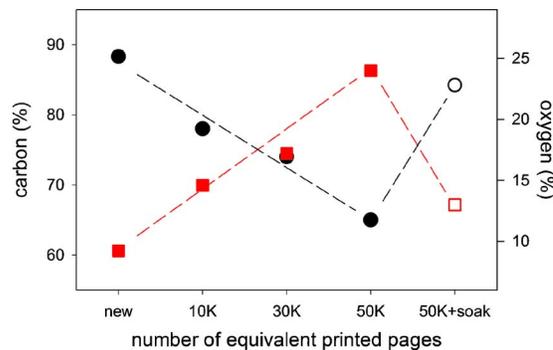
Figure 5. Carbon and oxygen concentration after a prolonged processing (5×10^4 equivalent printed pages; charge roller used).

Although both surface topography and wet etching data suggest that the chemically modified top region is on the order of several hundred nanometers, XPS data suggested yet another shorter range modification of the surface region. Carbon and oxygen are the major elemental components of the photoconductor as measured by the XPS (neglecting hydrogen). The prolonged exposure caused gradual changes of their ratio, as shown in Figure 5. These changes were associated with the corresponding modification of the molecular structures within the photoconductor's surface region (Figure 6). However, the low energy *in situ* ion beam sputtering combined with the XPS measurements showed that the observed modification of the photoconductor's surface region was limited to the top 50–60 nm (Figure 7).

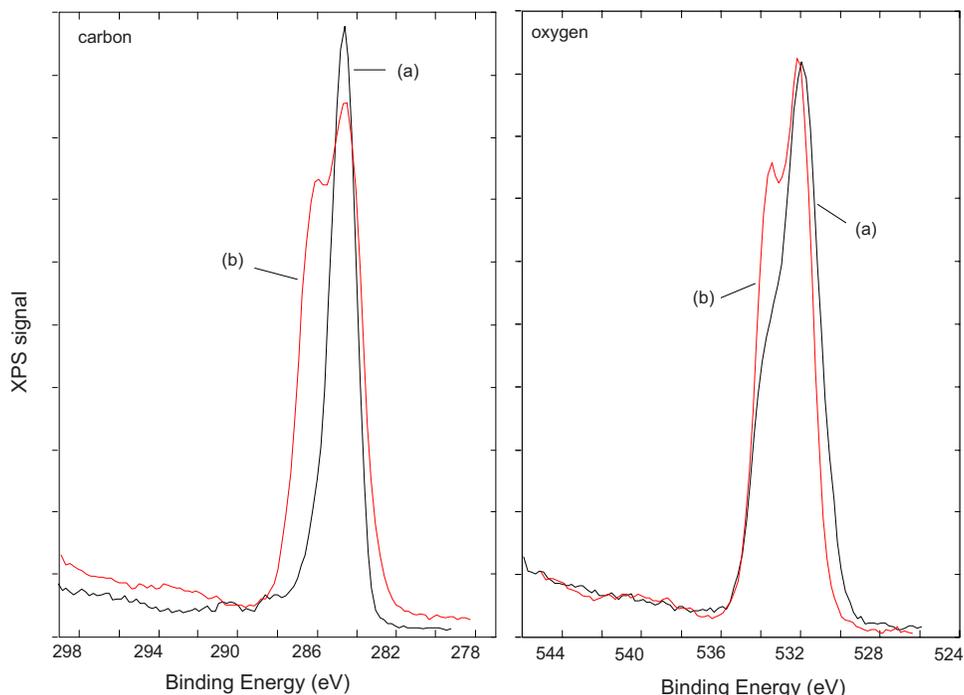
Figure 6. Changes in the molecular composition of a photoconductor as demonstrated by the chemical shifts of the carbon (C1s) and oxygen (O1s) XPS signals. (a) New photoconductor, (b) photoconductor after 50 K equivalent printed pages (charge roller used).

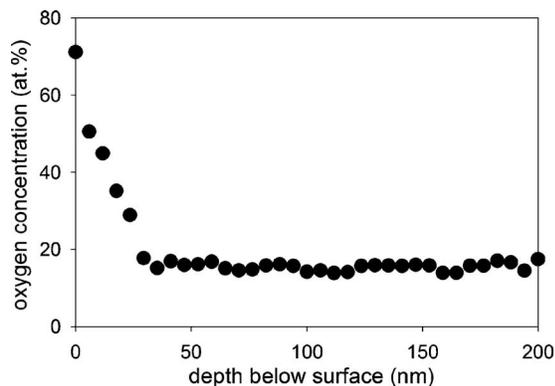
Figure 7. Oxygen depth profile after 6 h processing. XPS data were obtained by *in situ* low-energy beam ion sputtering followed by XPS measurement of freshly sputtered surface.

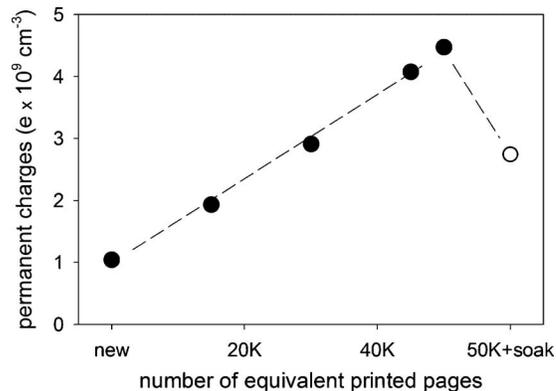
Figure 8. Permanent charges introduced by prolonged processing (Kelvin probe measurement).

A Kelvin probe measurement showed that extended processing caused a gradual increase of charge density within the photoconductor. Figure 8 presents photoconductor charge measurement approximately one week after the processing. Exposure of a photoconductor to an electrophotographic environment usually introduces a large surface charge buildup. The surface charges are then quickly dissipated and after several hours only permanent charges present within the photoconductor remain. These charges are likely due to molecular modifications introduced by plasma exposure. The aforementioned solvent soaking can
