Credible repair of Sony main-sensor PDAF striping artifacts

Henry Gordon Dietz; Department of Electrical and Computer Engineering, University of Kentucky; Lexington, Kentucky

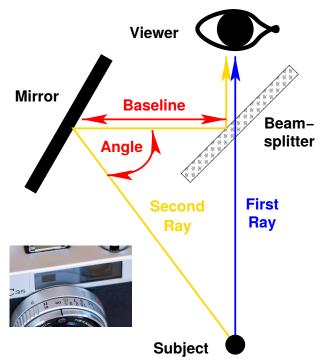
Figure 1. Optical coincidence range finder, as in Konica C35

Among the fastest and most reliable ways to manually focus a lens is an optical coincidence range finder, as shown in Figure 1. Light (blue) passes from the subject directly to the viewer through the beamsplitter (semi-transparent mirror), but also bounces there (yellow) off the mirror and beamsplitter. The angle of the mirror is manually adjusted so that the two images align, thus determining the angle shown in red and the distance to the subject is simply $\arctan(Angle) \times Baseline$. Thus, in rangefinder cameras, the focus adjustment is mechanically coupled to the turning of the mirror so when images align, the lens is focussed at the correct distance. Figure 2 shows the misalignment of the direct view and yellow-tinted patch from the rangefinder's reflected path.

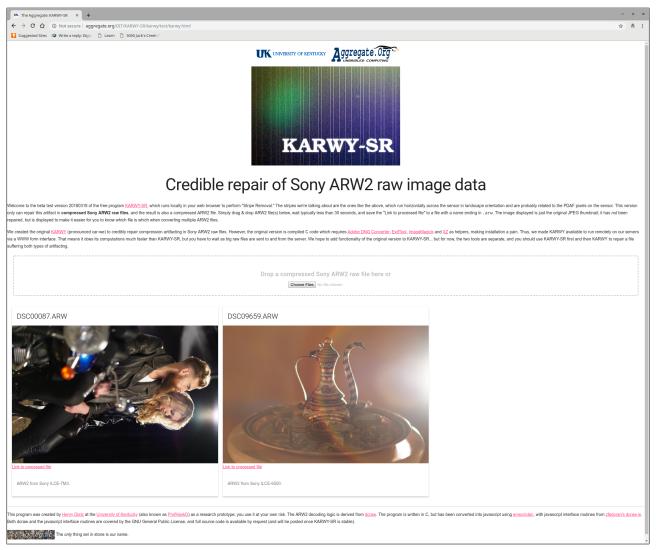
Figure 10. KARWY-SR interface (JavaScript running in a browser)
